Analysis of Housing Condition and Neighbourhood Quality of Residential Core of Akure, Nigeria

Owoeye, J.O

Omole, F.K

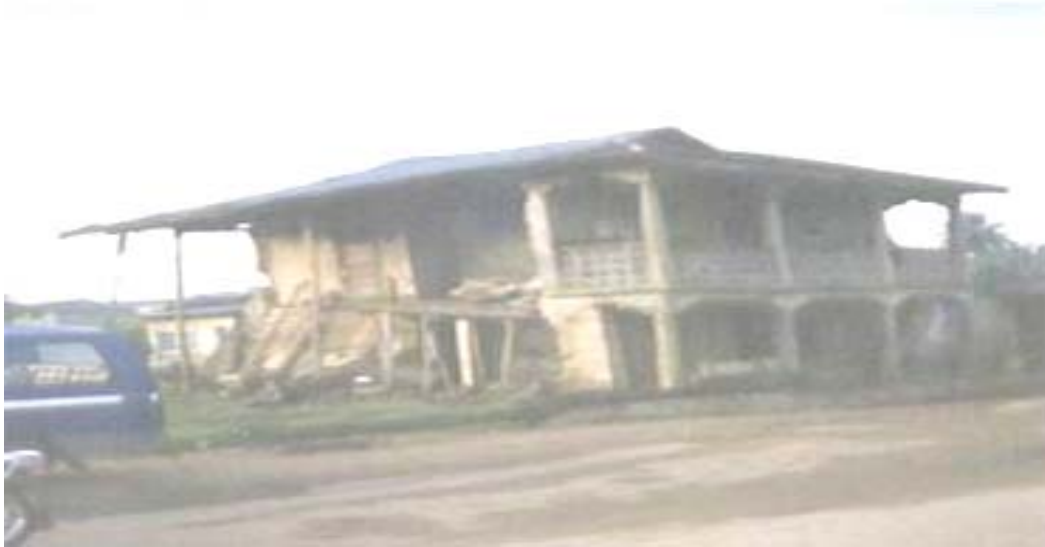
Plate 1a: Collapsed Buildings still inhabited by people due to high level of poverty
Source: Field Survey, 2010

The quality of housing in the study area, as shown in Table 1 below, is very low due to poor quality of building materials used for construction, the inadequate technology, and poor planning standard in handling the building components. Fadamiro (2002) argued that the average life-span of traditional mud building is 50 years. It therefore implies that quite a large proportion of housing stock in the study area are aged as over 80.0% of the sampled buildings have spent 30 years and above. Only 10.5% of the buildings are recent construction, which are just below 20 years. In his efforts to establish a correlation between relative habitability of housing and age, he affirmed that buildings erected in more recent time are more habitable than those built much earlier. Thus, a large number of the housing stock in the area has low relative habitability which has consequent effect on the state of health, socio-economic well-being and emotional stability of the residents (Adedeji and Owoeye, 2008; Oriye and Owoeye, 2010). Plate 1 shows the example of the condition of some of the buildings in the city core.

From the responses gathered, 97.8% of sampled housing units have zinc roofing material while only 2.2% has asbestos materials. About 79.1% are made with mud walling materials while about 21.0% have sand-crete blocks. This shows that the level of technology of building construction in the area is rudimentary. The assessment of maintenance level reveals that over 80.0% buildings need either minor or major repairs, out of which 18.3% are completely old and dilapidated. Only 15.2% exhibit evidence of physical soundness, while 62.6% roofing of buildings examined is patched and leaking.

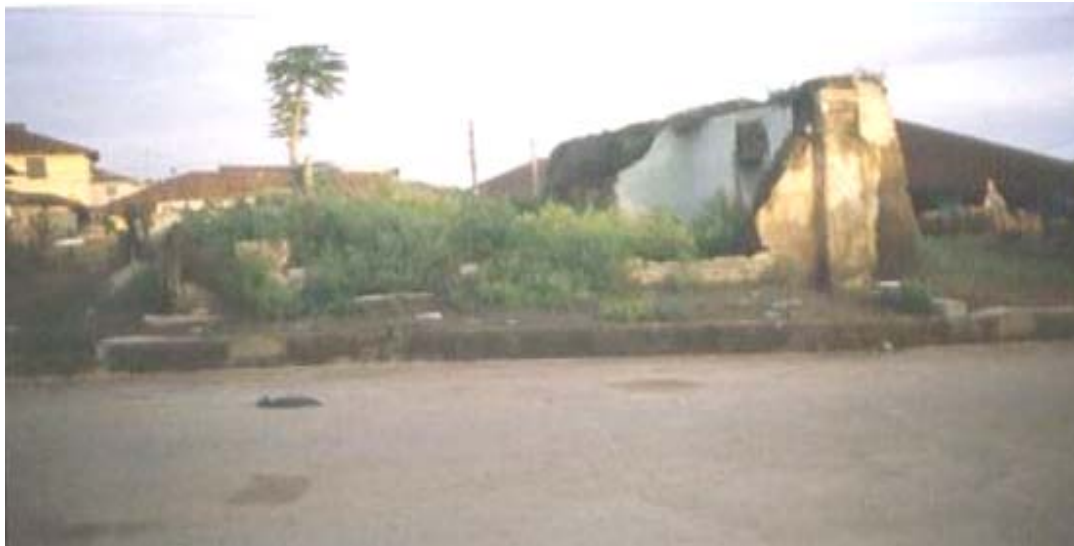
Plate 1b: Collapsed building left uncared for in the city core
Source: Field Survey, 2010

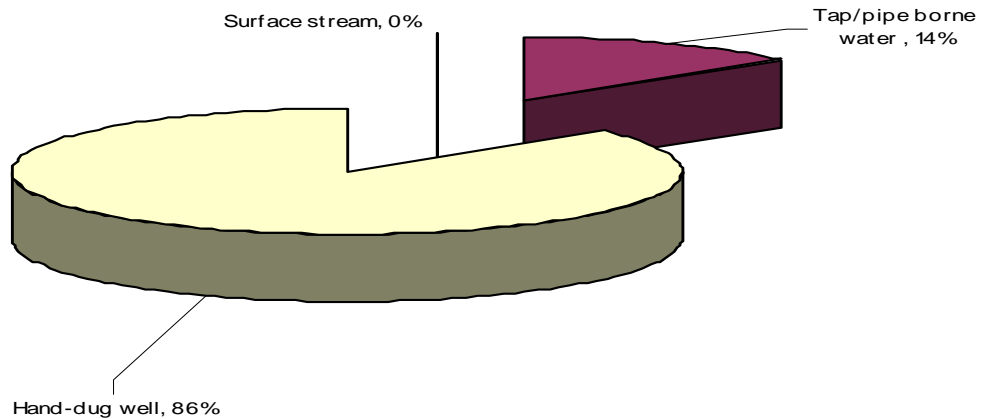
-Water Supply- Figure 2 reveal hand-dug well as the major source of water supply in the area, which accounts for 85.7% responses. Only 14.3% have access to tap water which is reported as not regularly available. This situation does not guarantee adequate supply of good quality water in the area. Most of the well, located in unkempt surroundings, are without cover while the water is used raw without treatment. The rain water used as substitute during raining season has the possibility of being contaminated as majority of the roofing sheets are rust and dirty.

Fig. 2: Source of Water Supply
Source: Field Survey, 2010

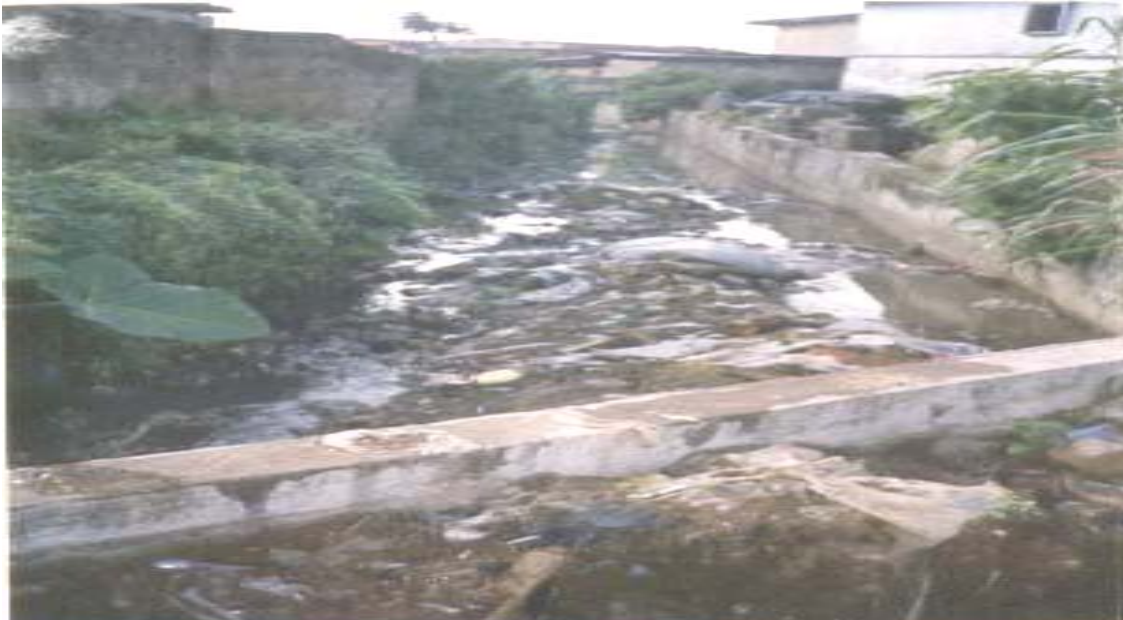
Plate 2a: Indiscriminate dumping of Refuse in drainages
Source: Field Survey, 2010

- **Wastes Disposal**- The condition of both sewage and solid wastes disposal facilities are shown in Table 2. Over 65.0% respondents used pit-latrines for sewage disposal. Only 10.9% used modern WC system while 23.9% do not have sewage management facility at all. Alternative methods used are either through mobile system (4.8%), bush or dung-hills (11.3%), streams or drainages (7.8%) or squatting in the neighbouring buildings. This makes the area look dirty, ugly and stinking (see Plate 3). The method of solid waste disposal too is generally absurd in spite of government efforts to curb indiscriminate dumping of refuse. Although, over 65.0% respondents used the controlled tipping method provided by the government through the agency of Waste Management Authority, but the remaining 34.8% dispose their refuse indiscriminately. Some (1.3%) dispose their refuse in open spaces, 11.7% through burning, 1.7% at road sides and drainages where nobody cares for them. Such become comfortable breeding grounds for rodents, flies, rats, mosquitoes and other dangerous animals that can contribute to the spreading of diseases and other related hazards in the environment. For example, the regular dumping of refuse in Ala River has caused blockage to the free flow of the river thereby leading to seasonal flooding into the premises of buildings around the place as indicated by 20.4% respondents. Clear evidence of this situation can be seen in Plate 2.

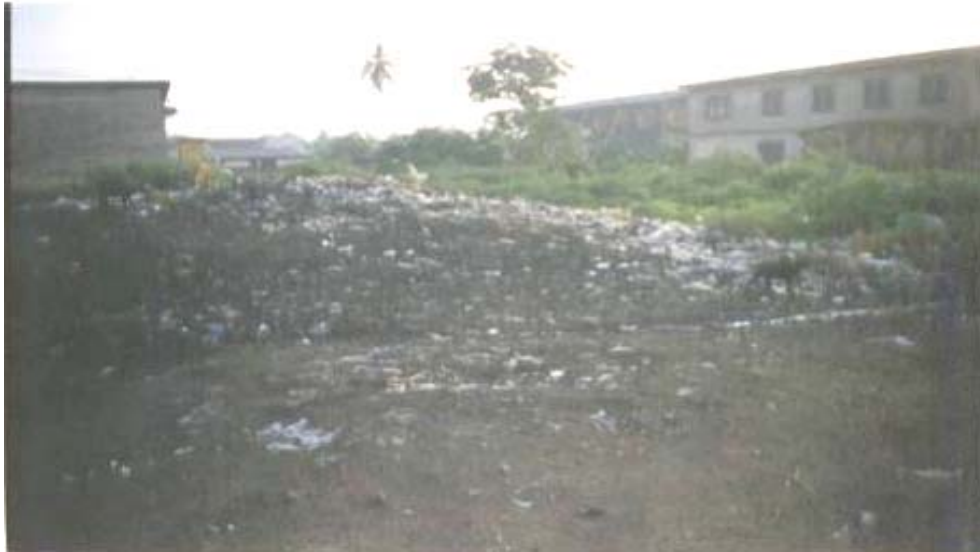
Plate 2b: Indiscriminate dumping of Refuse in Open spaces in the city core
Source: Field Survey, 2010

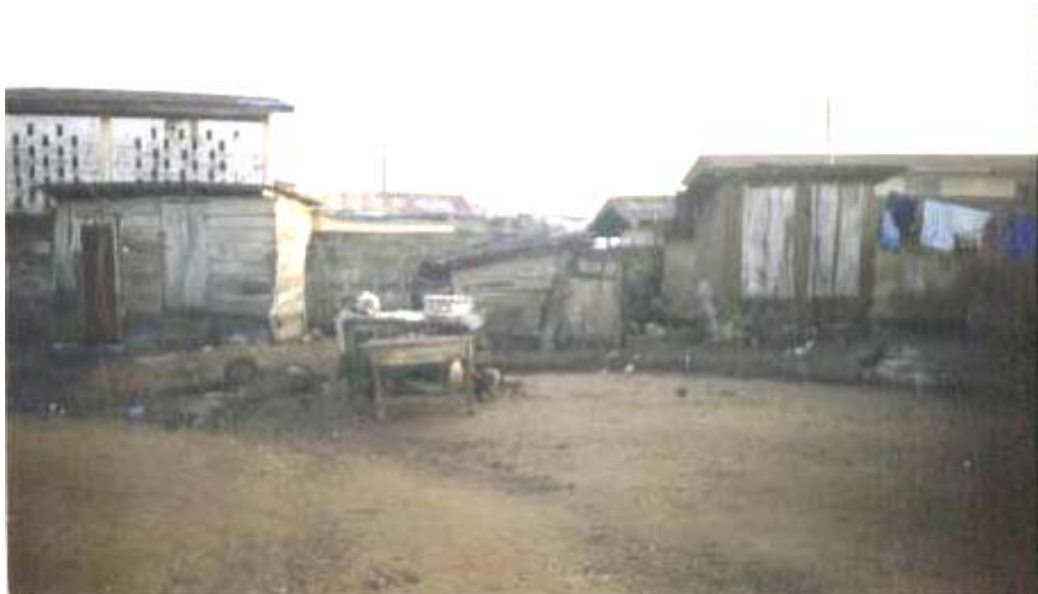
Plate 3: Bathrooms and Pit Toilets built outdoor in the city core
Source: Field Survey, 2010

- **Bathroom-** A good number of sampled houses has bathroom facility, only that they are rather substandard or inconveniently located. About 58.2% of the sampled buildings have bathroom within, but only 4.3% are self-contained while 53.9% are shared among several households which in most cases are being over utilized. About 31.7% have theirs outdoor, of small enclosure usually made of bamboo, rusted iron-sheets or planks; while the rest do not have provision for it at all. Such people become squatters in neighboring buildings. Plate 3 shows the condition of some of the bathroom in the study area.

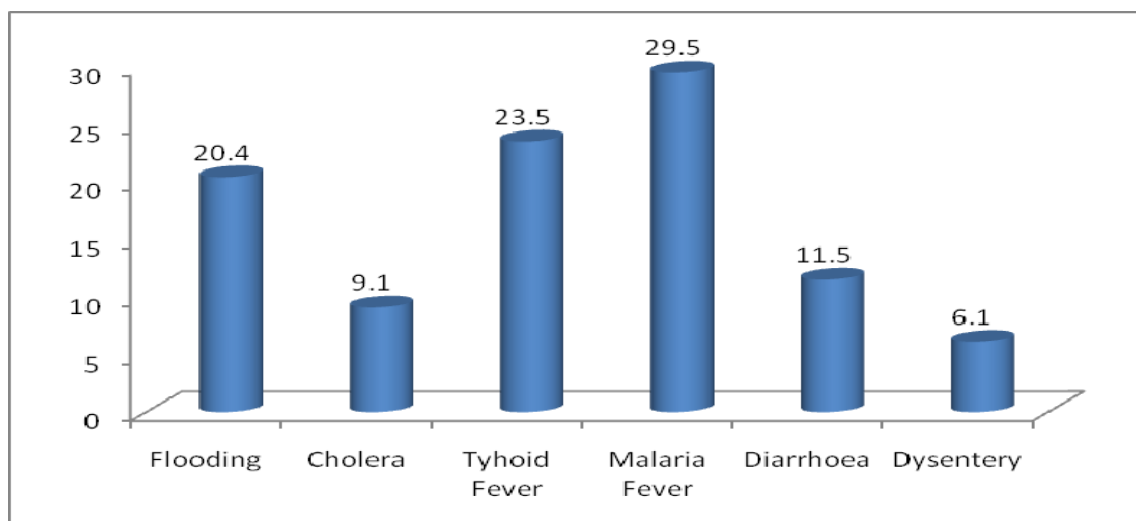
Various environmental related problems experienced in the area are shown in Figure 3 below. Their suggested causative factors include inadequate sanitary facilities as suggested by 57.4% respondents, poor water supply by 14.8% respondents, and dirty environment by 14.8% and overcrowding by 12.2% while 0.9% respondents suggested lack of good drainage system.

Figure 3 Environmental Related Problems in the Study Area.
